Total Land Subsidence in the Elfrida Area, Cochise County
Based on Sentinel-1 Satellite Interferometric Synthetic Aperture Radar (InSAR) Data
Time Period of Analysis: 2.0 Years 04/15/2019 To 04/16/2021

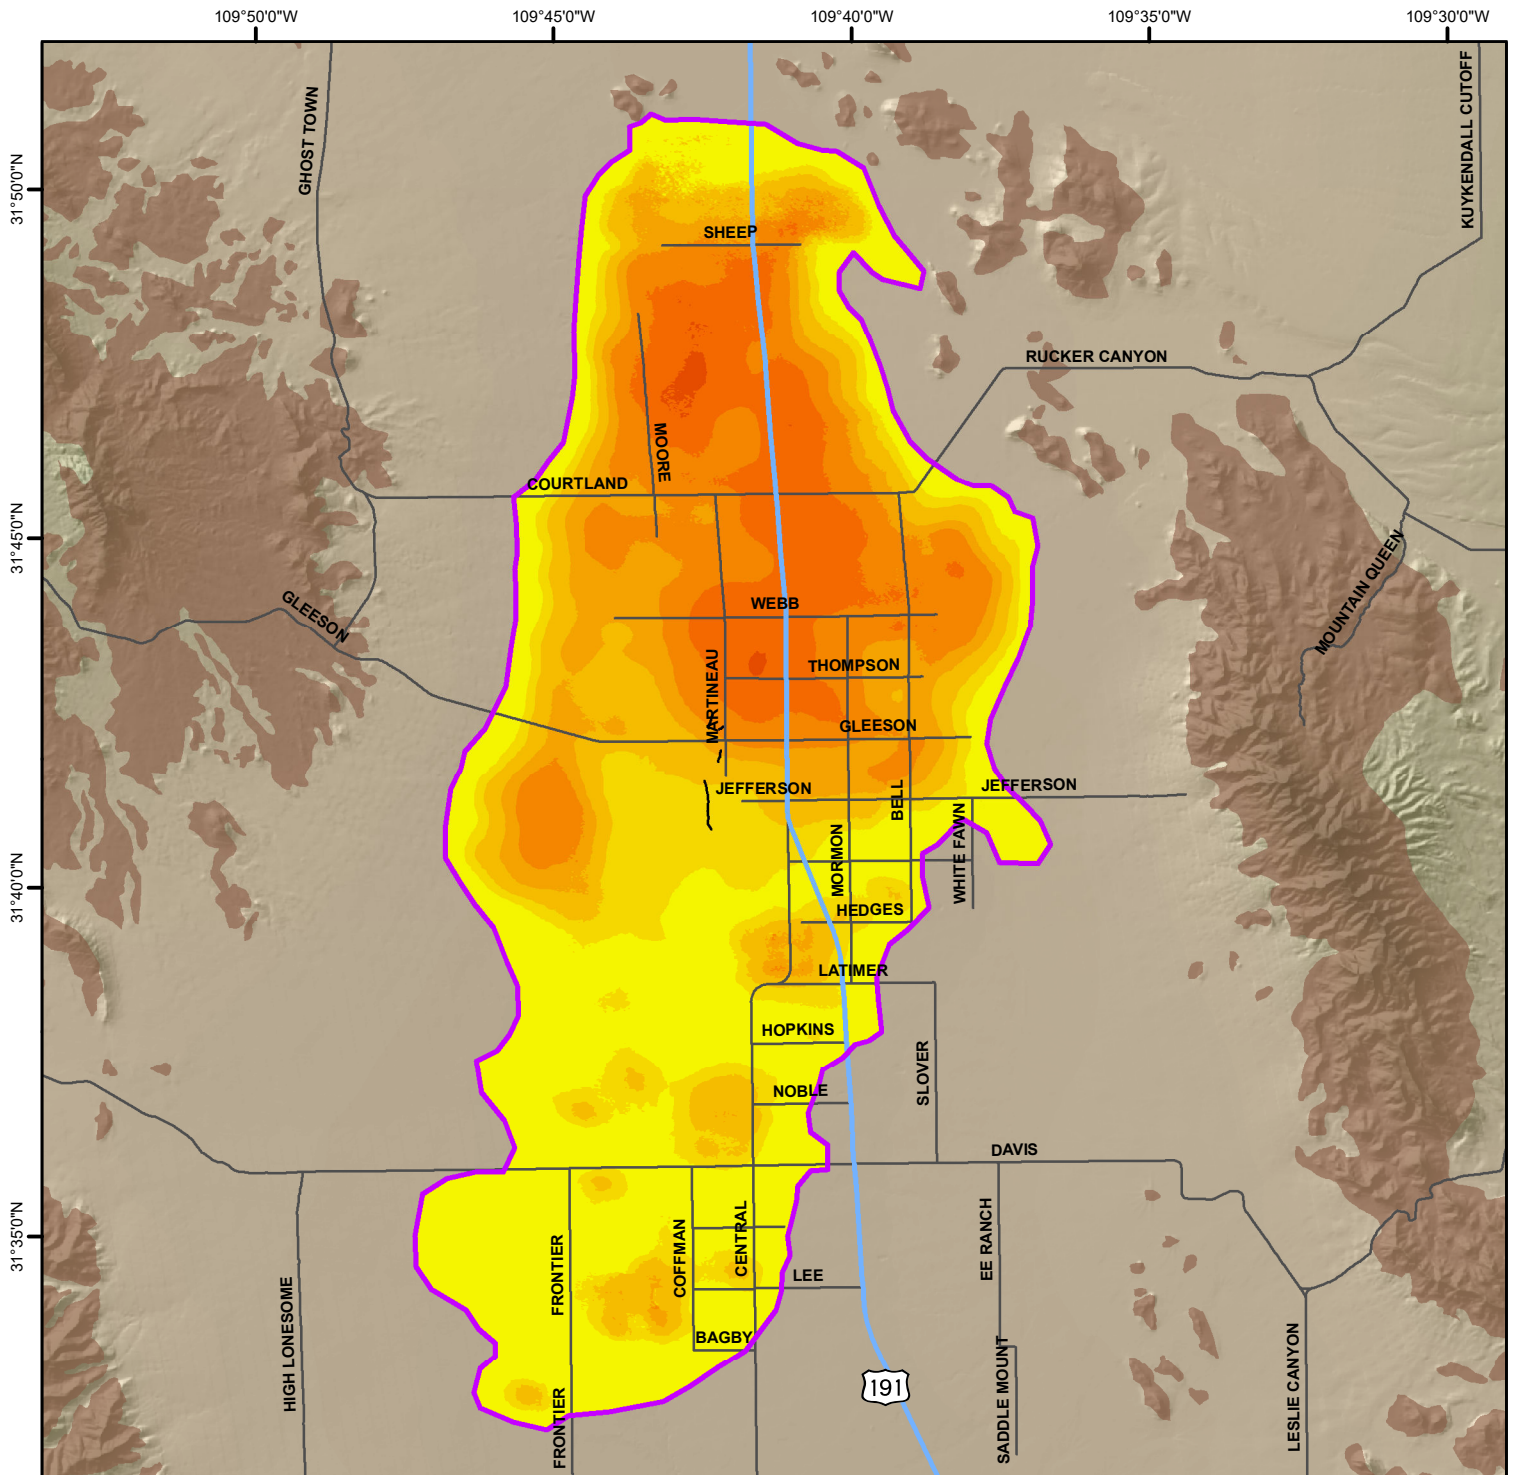
Decorrelation (white areas) are areas where the phase of the received satellite signal changed between satellite passes, causing the data to be unusable. This occurs in areas where the land surface has been disturbed (i.e. bodies of water, snow, agriculture areas, areas of development, etc).

Earth fissures were mapped by the Arizona Geological Survey.
 For information on earth fissures visit: www.azgs.gov/EFC
